Cape Lookout National Seashore  
**Cape Lookout Life-Saving Station**

# **HISTORIC STRUCTURE REPORT**

August 2003

2002  
Historic Structure Report  
Life- Saving Station  
Cape Lookout National Seashore  
Cape Lookout Village  
LCS#: 091835

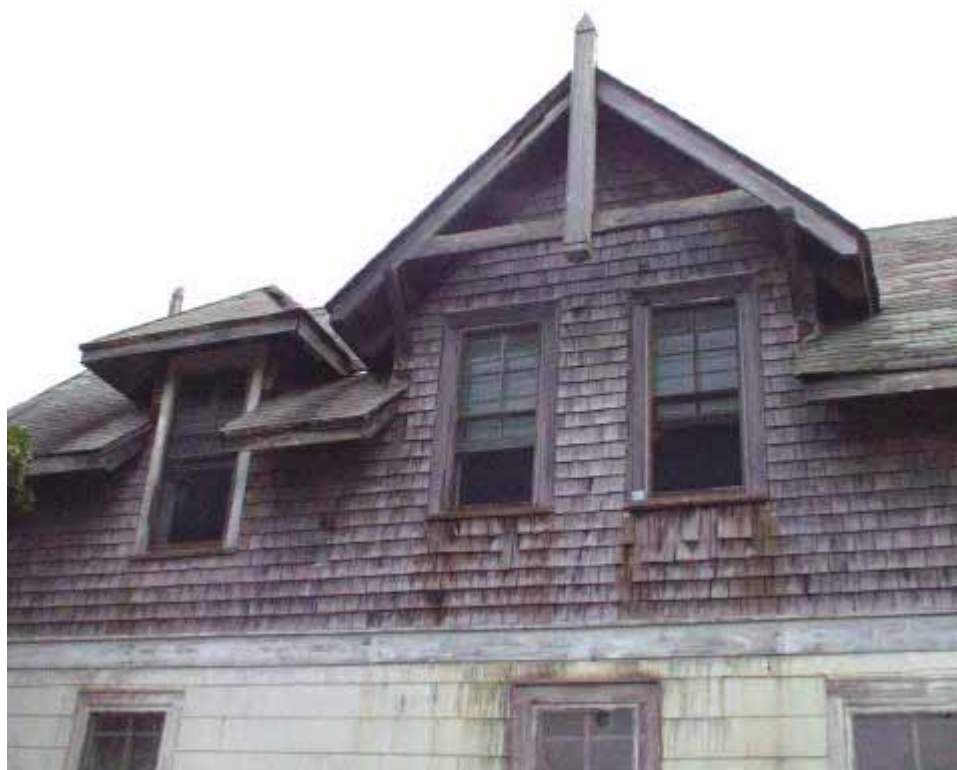
Most of the historic exterior finishes remain in place, although the original shiplap siding at the first floor has been covered with cement-asbestos shingles. The wood shingles at the second floor level are very worn, particularly on the south and west sides of the building, and there is widespread deterioration of other woodwork, due mainly to the failure to periodically repaint the building. The roof covering, which is now approaching thirty years old, is long past its useful life, and shingles are missing from several areas.

**Figure 11** View of typical exterior sidings, with wood shingles at second floor and asbestos over drop siding at first floor. (NPS-SERO-CRS, 2002)

- Remove and salvage cement- asbestos siding.
- Repair drop siding and wood- shingle siding.
- Repair and re- install missing gable finial.
- Repair all exterior woodwork as needed, matching existing materials.

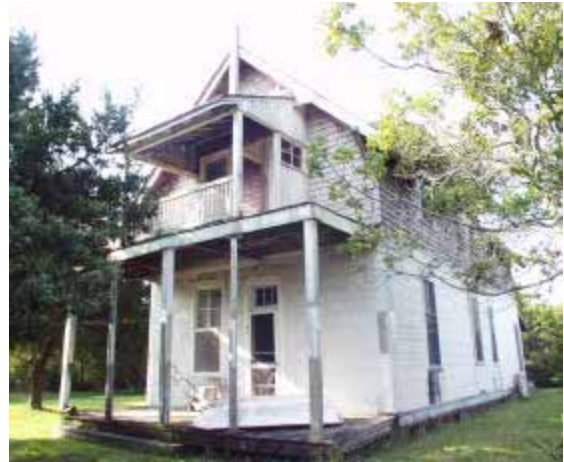
Structurally, the building is sound and in mostly good condition, the principal exceptions being some of the pilings and the front porches, which are badly deteriorated. The porch roof

at the second floor level has pulled away from the wall of the house as much as two inches, endangering the stability of the entire porch. In addition, the “lean-to” containing Room 100 (which was part of the original building) is in very poor condition, with portions of the floor severely rotted. Significant termite damage elsewhere in the building was not seen in the current investigation, but there is a very good likelihood of finding concealed damage once repairs get underway.

**Figure 16** View of front porches, added in 1920s. (NPS-SERO-CRS, 2002)

- Inspect and repair sills and joists when building is relocated.
- Reconstruct floor system in Room 100.
- Repair porches.
- Reconstruct front porch stairs.
- Rescreen front porch if desired.
- Reconstruct missing balustrades at both porches.

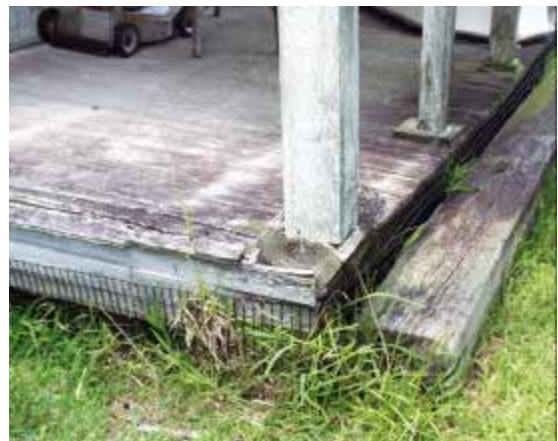
- 61** View of northeast corner of front porch, showing corner post seriously destabilized by deterioration of the sills at that location. (NPS-SERO-CRS, 2002) 81

**Figure 17** View of northeast corner of front porch, showing corner post seriously destabilized by deterioration of the sills at that location. (NPS-SERO-CRS, 2002)

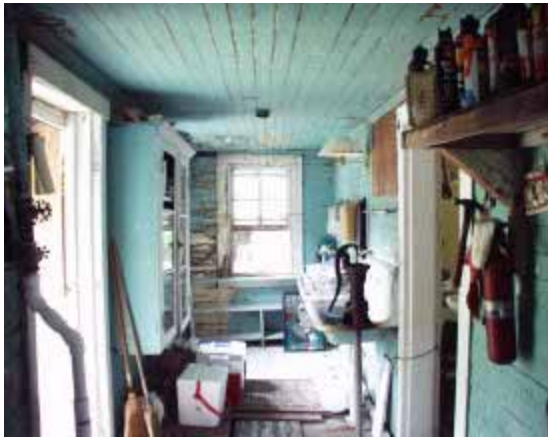
**Figure 21** View south in Room 100, showing location of original entry porch. Door opening at left replaced a window in the original configuration of the space. (NPS-SERO-CRS, 2002)
